Removing External Coatings from Steel Drums During the Reconditioning Process

Reusable Industrial Packaging Association
Guidance Document | March 2018

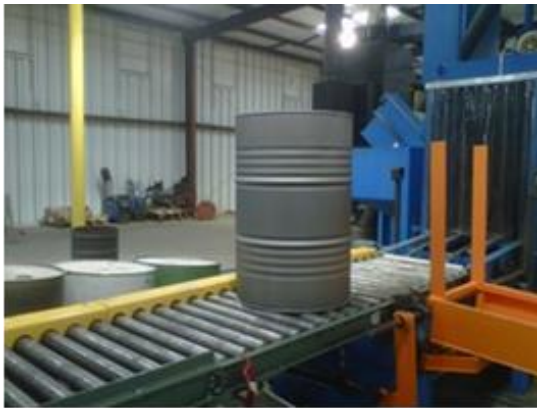
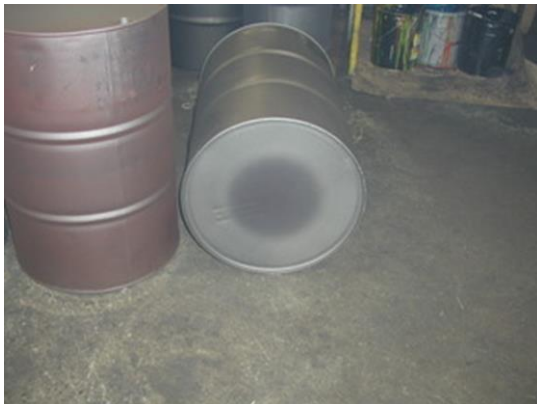
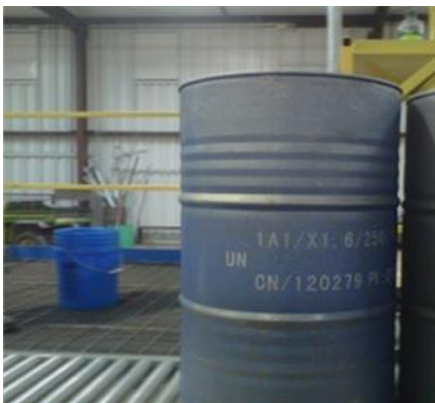
Appropriate and reasonable
(shot blasted drums)

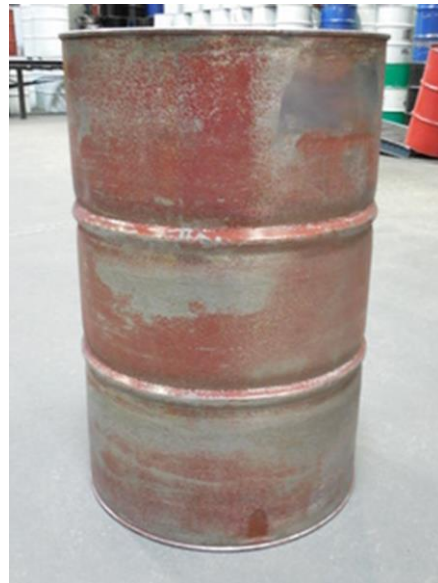
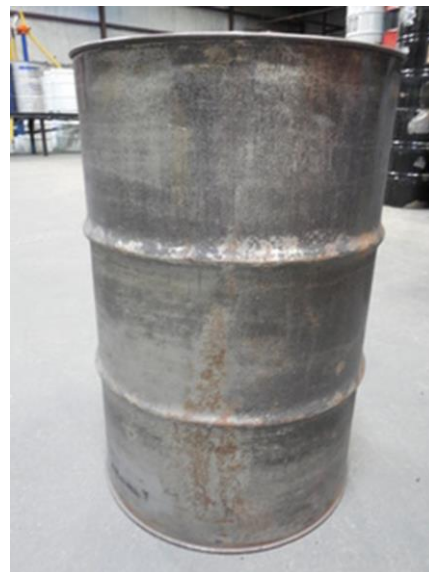
Appropriate and reasonable
(shot blasted drums)

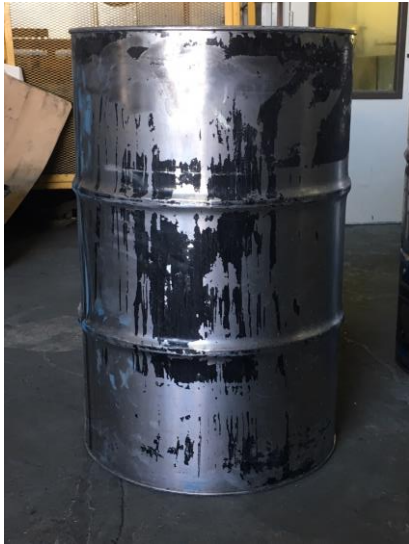
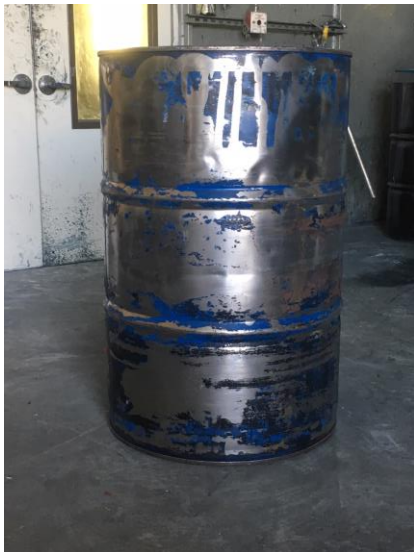
Appropriate and reasonable (cont')
(brushed drums)

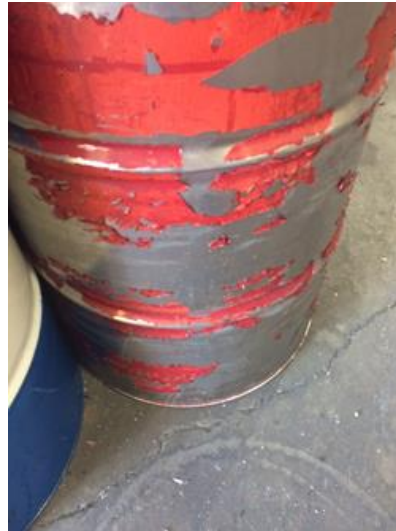
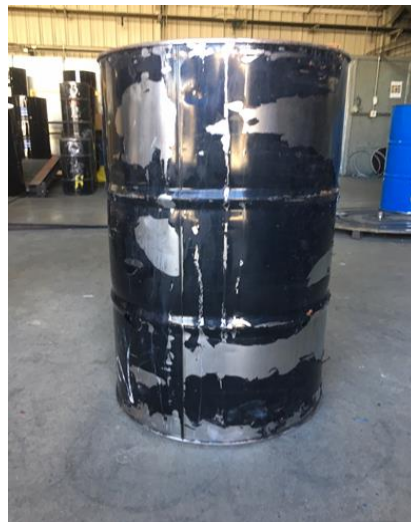
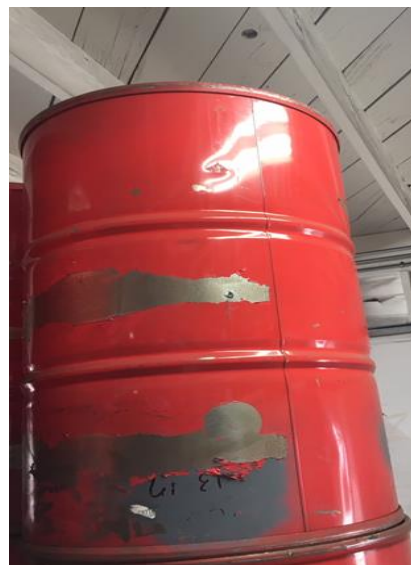
Needs Further Processing
(see flaking)
