Reusable Industrial Packaging Association

Guidance Document

Removal of Coatings from Steel Drums During Reconditioning

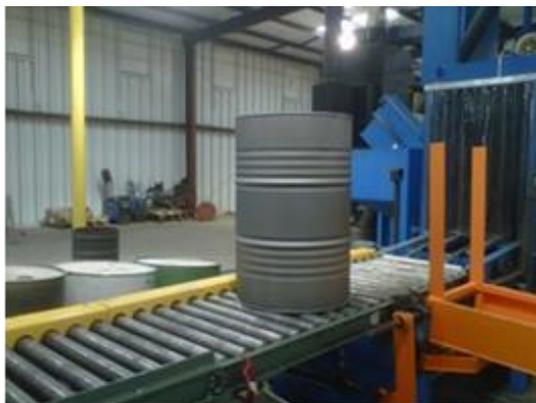
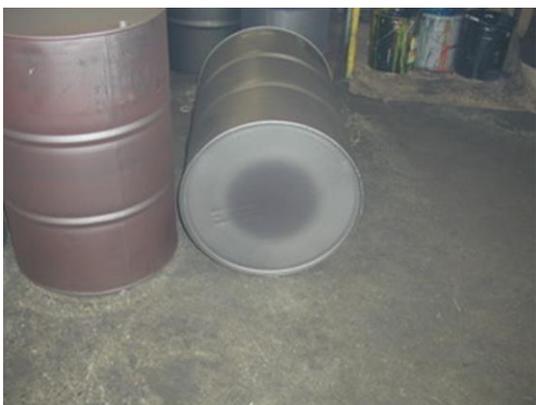
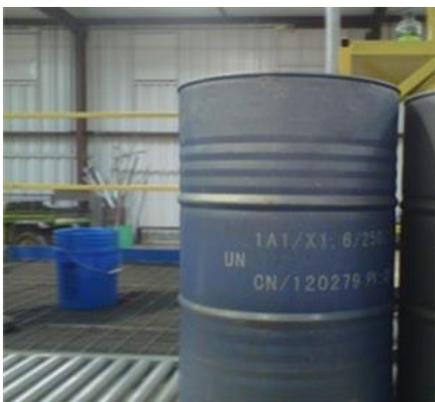
SUFFICIENT

To this end, RIPA has developed a visual guide for its members that shows with the aid of photographs appropriate and reasonable amounts of coating material remaining on reconditioned drums. The photographs help differentiate outer surface cleaning following both shot blasting and brushing operations.

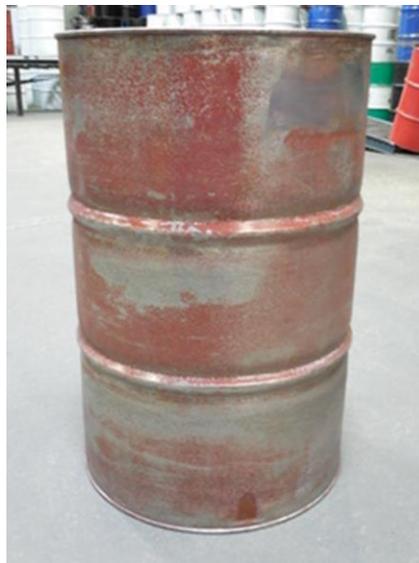
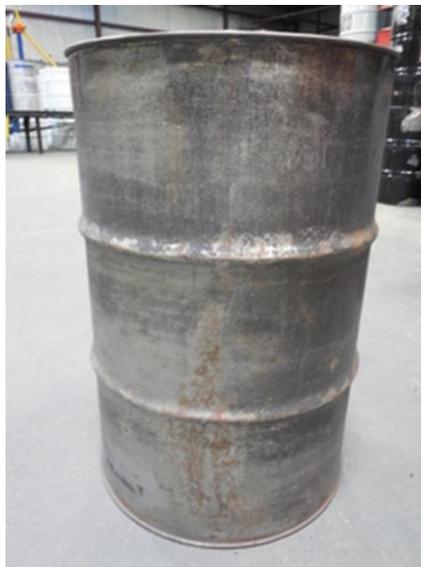
SUFFICIENT

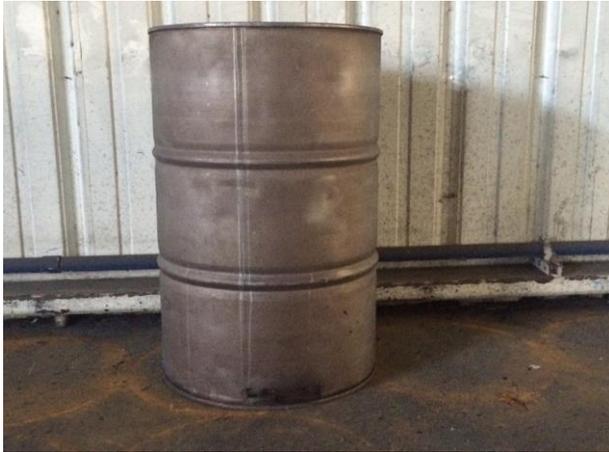
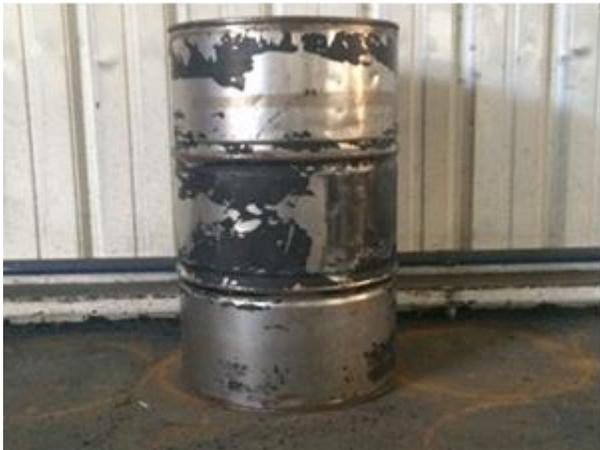
SUFFICIENT (cont')

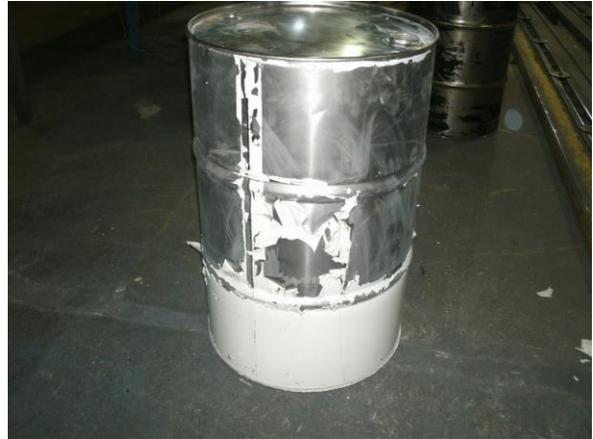
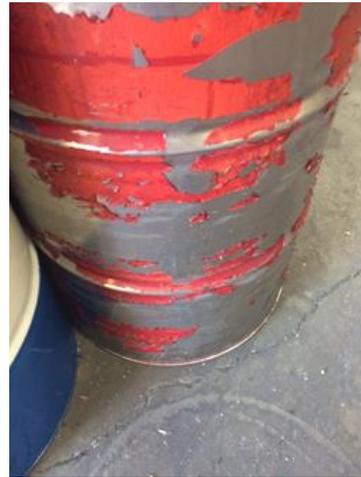
INSUFFICIENT (see flaking)
